SITE INSPECTION REPORT
UNIVERSAL MANUFACTURING COMPANY
WOODINVILLE, WASHINGTON

Report Prepared By:
Suzanne E. Milham
Washington State Department of Ecology
Preliminary Assessment/Site Inspection Program

April, 1986

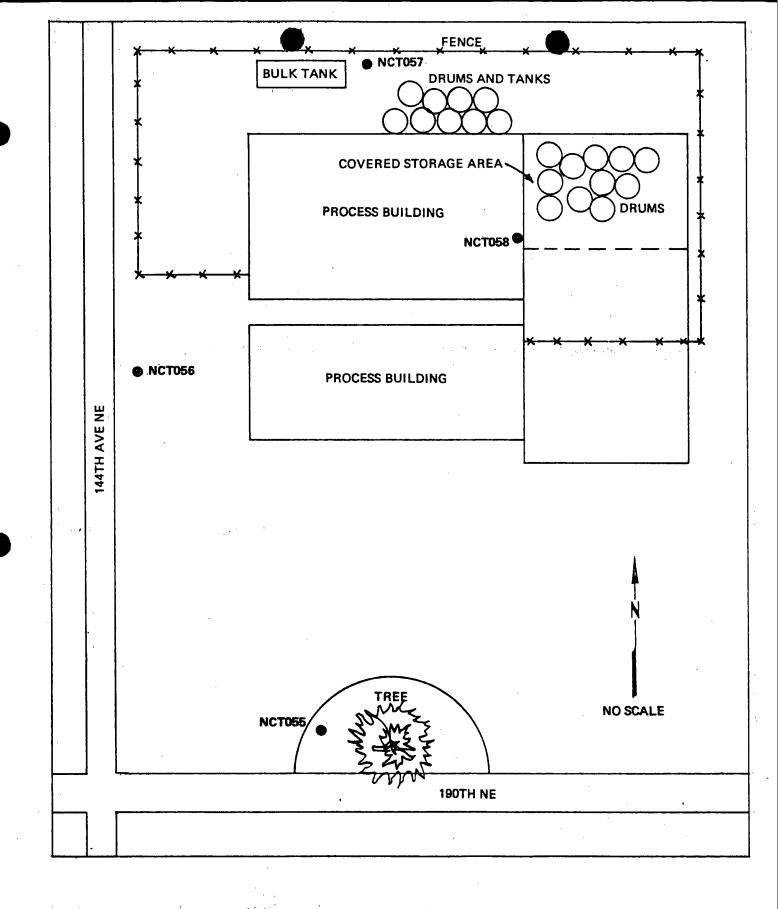
Figure 1. UNIVERSAL MANUFACTURING SITE SAMPLING LOCATIONS, WOODINVILLE, WASHINGTON, 10/23/85.

At 10:30 a.m., we met at Universal Manufacturing with Don Chang and Bill Heaton of the King County Health Department. An interview with the site owner, Mr. Jenkins, was conducted and arrangements were made to collect a number of on-site soil samples. Sampling locations were chosen after a site tour and review of the process and storage areas (see Figure 1).

Soil Sample NCT055 was collected first at 12:50 p.m. This location is near 190th Avenue in front of the facility near a willow tree. This sample location was upgradient from the process area and was intended to represent background soil. The sample was taken at a depth of approximately 1-1/2 foot. The soil was dark black and loamy, with many 1-2 inch diameter smooth rocks interspersed.

Soil sample NCT056 was collected on the bank of the parking lot along 144th Avenue. This area may have received overflow from the septic drainfield and the old waste lagoon. Approximately 6" of ornamental bark covered a layer of plastic and the soil. The sample was taken from a depth of approximately 2 feet. The soil was similar in description to that at to location NCT055.

Soil sample NCT057 was collected from behind the main building near the large metal storage tank in an unpaved area. This tank is used to store process wastes; it is unknown if it was filled or empty. The soils were extremely rocky and consisted almost exclusively of smoothed gravel, medium to large rocks and sand. The sample was collected at approximately 2 feet deep. There was a foul hydrogen disulfide smell present in this location, soil pH was measured and appeared normal. This location was chosen in the event that soil contamination from spills while filling this tank had occurred.

Soil sample NCT058 was collected between the two process buildings in a small unpaved area next to the circuit board shop and covered storage area. Split samples were collected from approximately 2-1/2 feet deep. The soil was comprised of wet gravel and sand. At 2-1/2 feet, there was a layer of reddish-orange material, possibly clay. This collection site was chosen because it was the closest unpaved area to the old waste lagoon.

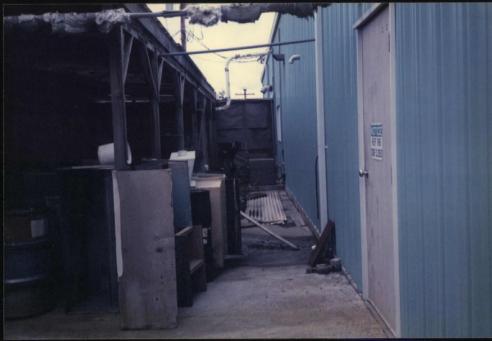
At approximately 2 feet deep there was an orangish color to the soil. This location was immediatly adjacent to where several open full drums of chemicals were being stored.

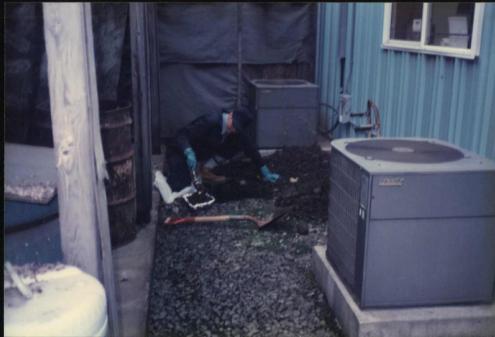
Background sample #NCT055 being collected on the South side of the complex by Ned Therien.

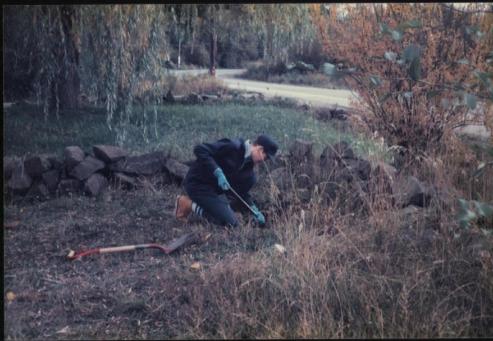
Sample NCT056 was taken here on the West side of the complex near where the old septic leach field was located. Ned Therien is seen collecting the sample.

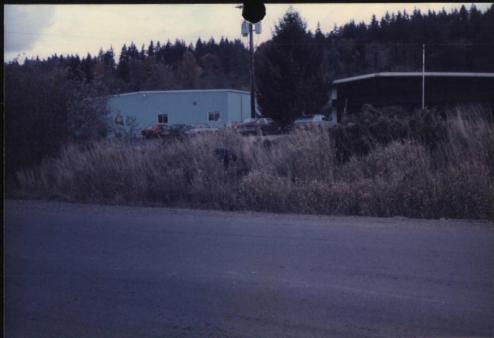
Sample NCT057 was taken near an unpaved waste storage area on the east side of the site. The large storage tank which was full at the time of the

in these photos.

inspection can be clearly seen

Sample NCT057 was taken from behind the main building near the large metal storage tank in an unpaved area. The soils were extremely rocky - consisting almost exclusively of smoothed gravel, medium - large rocks, and sand. Soil was dug to approximately 2 feet depth. A foul  ${\rm H_2SO_4}$  smell was present in this hole, the cause is unknown. The pH of the wet soil was measured and appeared normal.

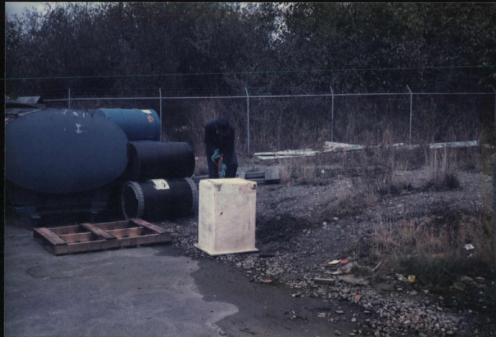
Sample NCT057 was taken in this location, the type of sand and gravel soils present can be seen in this photo.
